## Damage of Houses and Residential Areas by Niigata Prefecture Earthquakes (Part 1)

### ABSTRACT

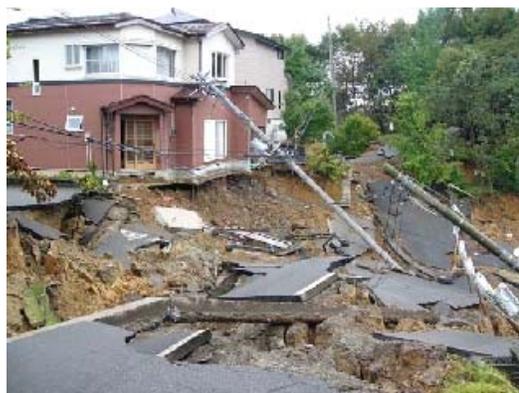
Many of the damaged houses were homes where the house bearing ground was lost as a result of slope collapse or landslide of the earthfill in the buried ravines, which resulted in damage such as building inclination and cracks in structure foundations.

Fig.2 Collapse of buried ravine earthfill

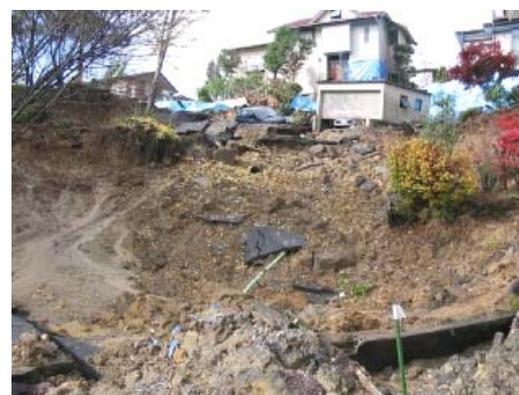
Fig.3 Collapsed residential land

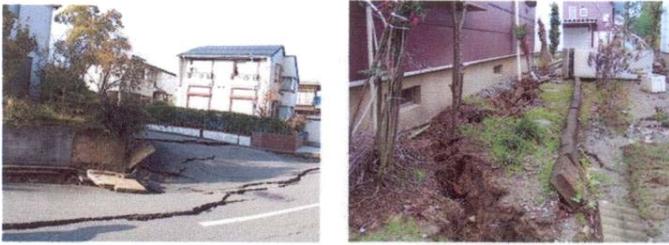
As shown in Fig.4(a)(b), such damage was not limited just to the perimeter areas and fractures and faulting of residential land and streets inside the perimeter road occurred in a number of locations. These areas are conjectured to be near the boundary between the cuts and earthfill. Houses where ground fissures opened directly beneath the house suffered damage such as foundation cracking, but on residential land where ground fissures veered away from houses, homes frequently escaped damage.

Fig.4 (a) Fractures and faulting near perimeter edge (b) Fractures and faulting of residential land

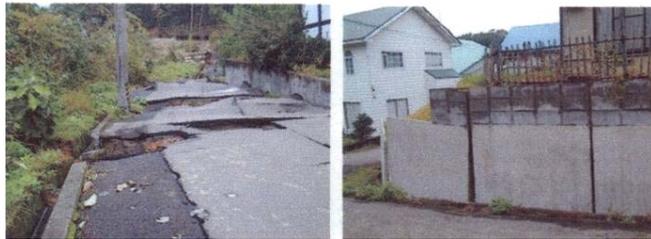
Fig.5 shows the damaged condition of a flank road on this residential land, where a landslide occurred in the direction of the storage reservoir.

Fig.6 shows an example of a retaining wall made a reinforced concrete, on a residential lot located on sloped land upstream of the storage reservoir, which was slid more than 1m. Although soil improvement was performed as a normal countermeasure to prevent settlement, the house was inclined toward the direction in which the retaining wall had slid.

Fig.5 Road collapse caused by landslide

Fig.6 Slide and settlement of residential land retaining wall

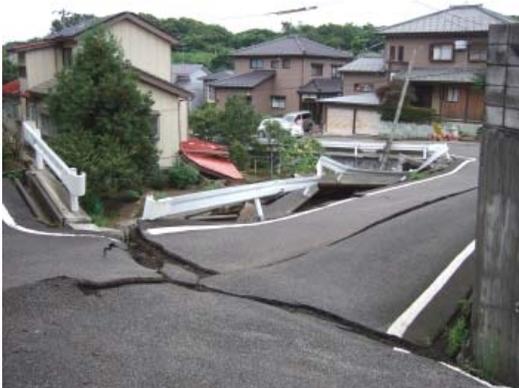
In the 2007 earthquake, residential land made with earthfill on sloped land on sandhills suffered a circular arc landslide over an area 30m wide and 60m long( Fig.7 and 8). There were six homes located within this range. The houses in the vicinity of the top part of the slide were moved 1m horizontally and subsided by more than 50cm. The houses in the center of the slide area suffered broken foundations and the houses were completely destroyed. The first floor area of the houses at the edge of the slide was completely destroyed by earth surge.

Fig.7 Lower side of slide

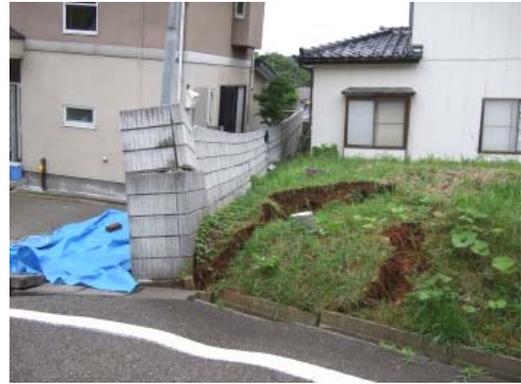
Fig.8 Upper side of slide

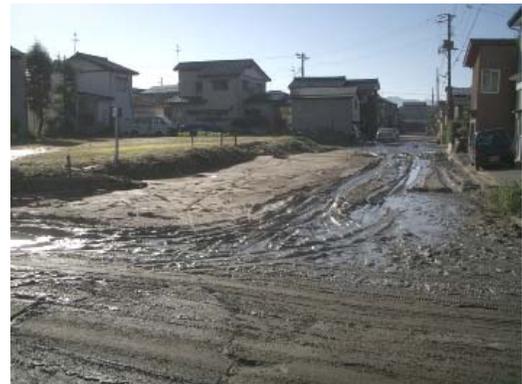
In the 2004 earthquake, liquefaction occurred in the vicinity of the Kariyata River, a branch of the Shinano River. Roads in the area affected by liquefaction were covered with sand boils and muddy water (Fig.9).

Fig.9 Road buried under sand boil

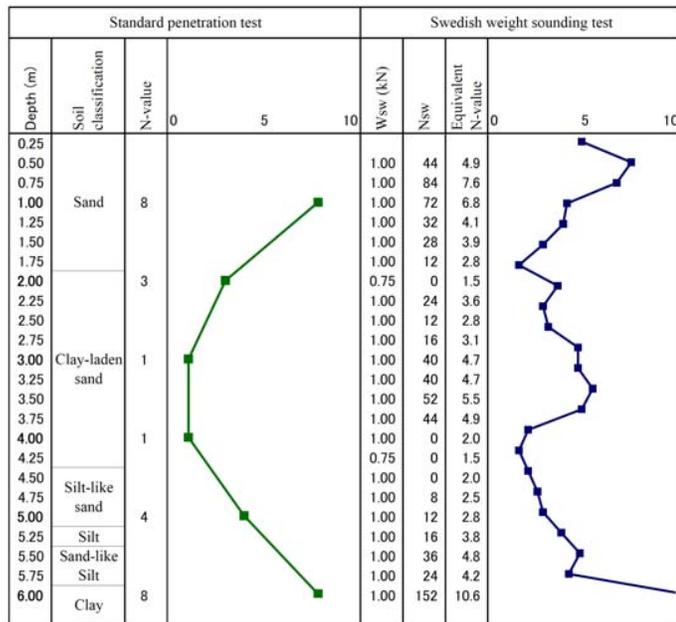
Figure 11 (Wakame, et al, 2005) shows the results of the standard penetration test and Swedish weight sounding tests conducted at the sites where liquefaction occurred, and Fig.12 (Wakame, et al, 2005) shows the grain size distribution of the soil samples collected during the standard penetration tests. In Fig. 11, the N-values for the standard penetration test are extremely small, ranging between GL-3.0-4.0m, in contrast to the results of the SWS tests, which exhibit a different trend.

Fig.11 Results of SPT test and SWS test

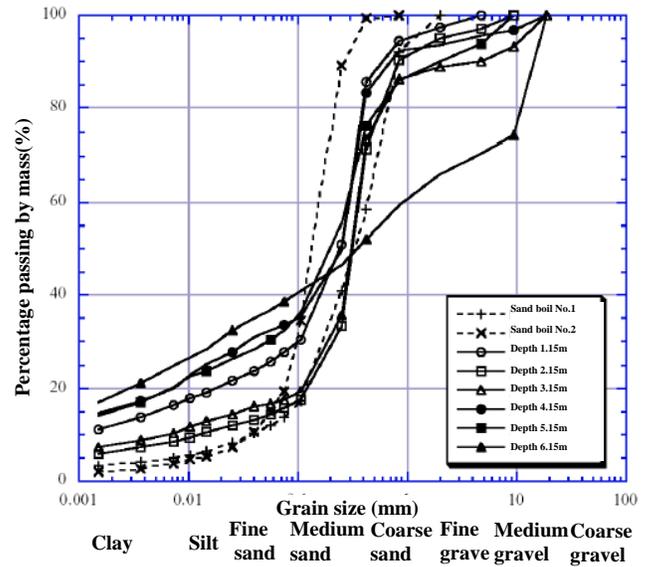
Furthermore, according to the results of the grain size analysis, the nature of the soil of each depth is classified as sandy soil, but at depths greater than GL-4.0m the figures shows  $F_c$ (Fine fraction content) $>30\%$  and  $P_c$ (Clay content) $\geq 10\%$ , and the percentage of fine grained soil content has increased.

Fig.12 Results of grain size analysis

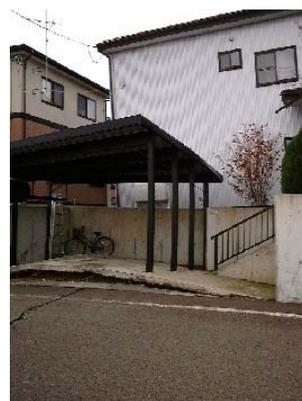
Figure 14 (Matsushita and Tamura, 2005) shows the results of the SWS test conducted at the site where liquefaction damage occurred. A stratum with a low resistance value, from the ground surface to a depth of approximately 6m, was confirmed. Because the houses that suffered damage settled by sinking into the ground surface, the liquefaction is conjectured to have occurred in a comparatively shallow stratum. Moreover, the site has a 1.5m high retaining wall, and it is thought the water level behind the wall had risen, thus causing the damage to be more extensive (Fig.13). In addition to house settlement, upheavals of earth floors and streets caused by sand boils also occurred.

Fig.13 House settlement and upheaval of earth floor

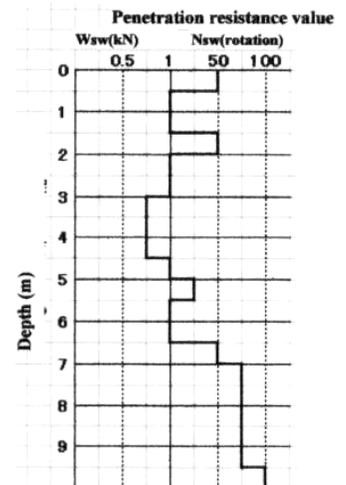
Fig.14 Results of SWS test

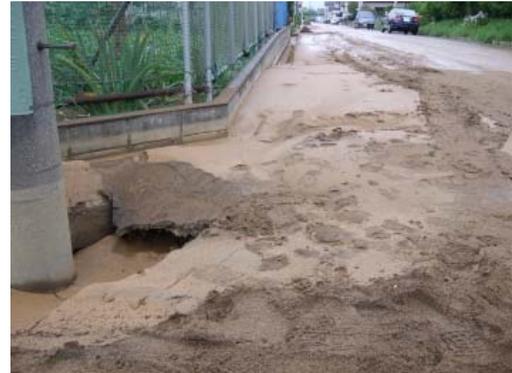
At Site A, houses that suffered structural damage caused by liquefaction were dwellings located near the boundary of the sandhills and low-lying alluvial ground or houses on residential land that had been filled prior to house construction.

Fig.18 Sand boil caused by liquefaction

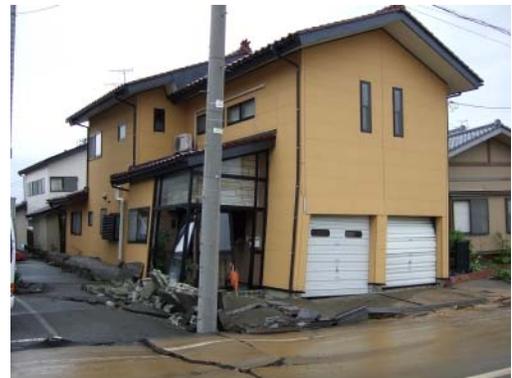
Fig.19 Deformed house

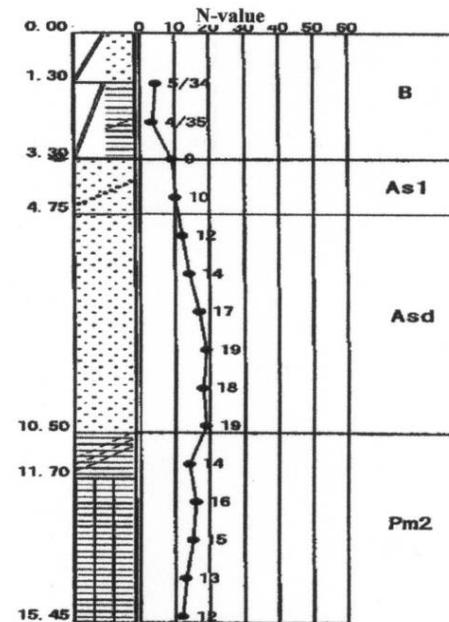
Fig.20 shows the results of the standard penetration test on the residential area ground where damage caused by liquefaction occurred, and Fig.21 shows the results of the liquefaction layer grain size analysis.

Fig.20 Results of standard penetration test

Sand strata composed mainly of medium sand are distributed from GL-3m to about GL-11m, showing an N-value of roughly 10-20 and

comparatively high “median” relative density at depths of GL-4m and lower. At GL-3m, the ground water level is high. Maximum ground level acceleration is estimated to have been about 400gal, and liquefaction is thought to have occurred in ground where large acceleration had a comparatively high N-value.

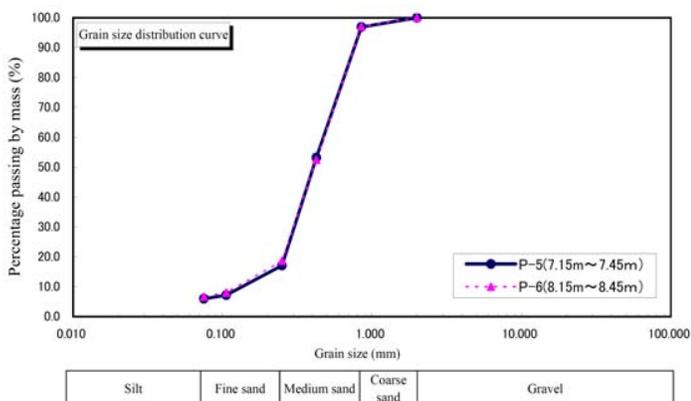
Fig.21 Results of liquefaction layer grain size analysis(GL-7~9m)

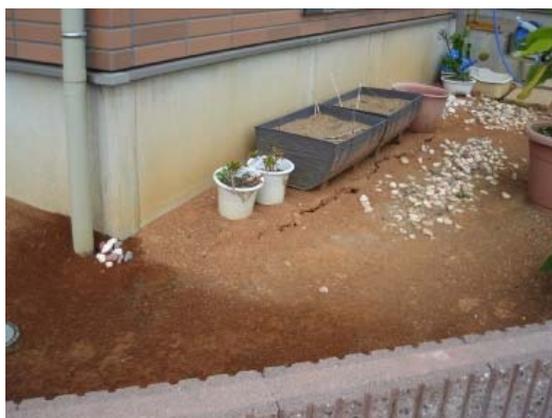
Houses where soil improvement to the load bearing stratum had been undertaken as a normal measure against settlement were also confirmed to be effective against liquefaction (Fig.22).

Fig.22 Result of soil improvement, heave
