## Damage of Houses and Residential Areas by Niigata Prefecture Earthquakes (Part 1)

### ABSTRACT

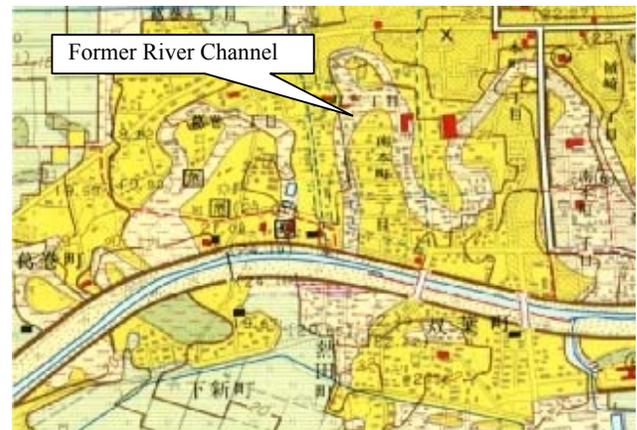
Fig.10 Topographical map

In this area an urban district has formed centered on the natural levee along the Kariyata River, although it also contains a number of houses built on reclaimed land. From the topographical map shown in Fig.10, (Geographical Survey Institute) the peripheral reclaimed land can be seen to meander, following the former river channel of the Kariyata River. Liquefaction generally occurred in places located along this former river channel.

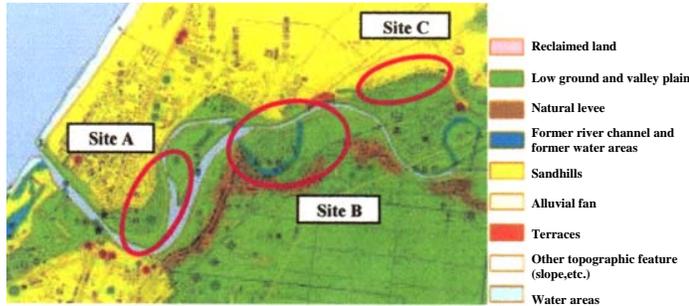
Fig.15 Geomorphological land classification map (Geographical Survey Institute)

Figure 15 shows the areas where liquefaction caused by the 2007 earthquake occurred. Damage caused by liquefaction was concentrated

around the bases of sandhills and in the vicinity of the Sabaishi River.

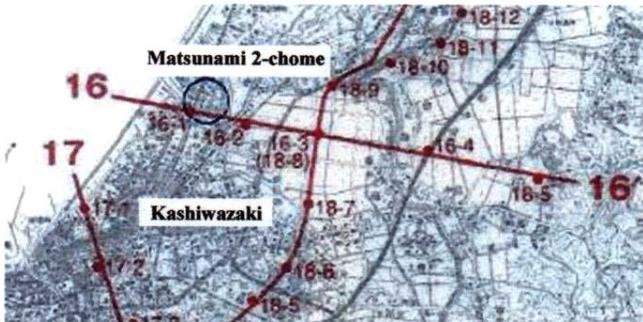
Fig.16 Geologic cross section position map

This region lies in the vicinity of the boundary where the alluvial deposits rapidly become very deep, as shown in Fig.16 and Fig.17. The thickness of the alluvial deposit layer ranges between 50 to 70m. Alluvial sand strata or reclaimed land were distributed in the areas where liquefaction occurred.
